Manhole Inspection Summary

Manhole # S05YY_018MH

Insp Date: **12/23/08 3:11 PM**

Location Address: **3901 LIBERTY HEIGHTS AVE**

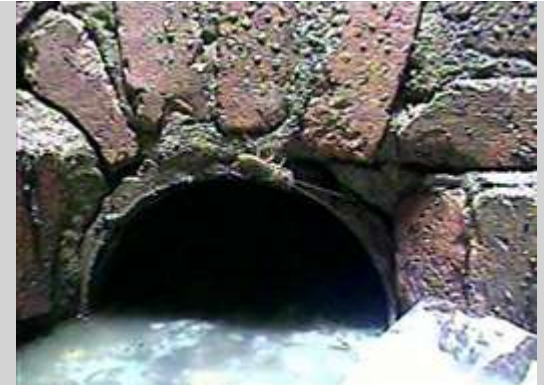
12 O'Clock Outflow

8 in. Circular Gravity Sewer
Pipe Out @ 12 O'Clock

Pipe Height: (in.) Direct
Pipe Material: **Clay** ☐ Pipe Lined
Invert Depth: **7.13** (ft.) Flow Characteristics: **Slow**
Deposits: ☒ None ☐ Mud ☐ Sludge ☐ Debris ☐ Grease
Silt Depth: (in.) Deposits Extent:
Infiltration: **None** Pipe Seal Cond: **Sound**

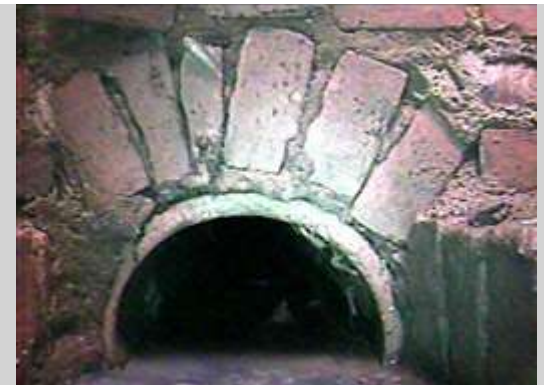
4 O'Clock Inflow

8 in. Circular Gravity Sewer
Pipe In @ 4 O'Clock

Pipe Height: (in.) Direct
Pipe Material: **Clay** ☐ Pipe Lined
Invert Depth: **7.09** (ft.) Flow Characteristics: **Slow**
Deposits: ☒ None ☐ Mud ☐ Sludge ☐ Debris ☐ Grease
Silt Depth: (in.) Deposits Extent:
Infiltration: **None** Pipe Seal Cond: **Sound**

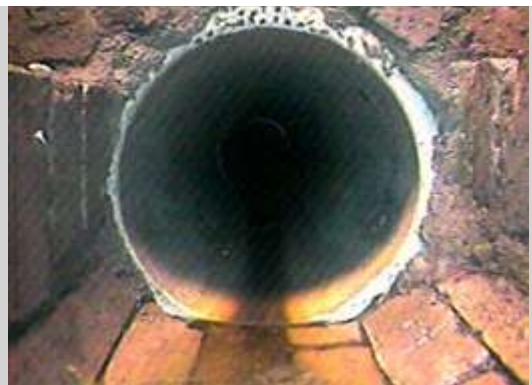
7 O'Clock Inflow

8 in. Circular Gravity Sewer

Pipe In @ 7 O'Clock

Infiltration: **None** Pipe Seal Cond: **Sound**
